HYDRO-GARD INC.

**SHORED WALL
BACKLAGGED CONDITION**

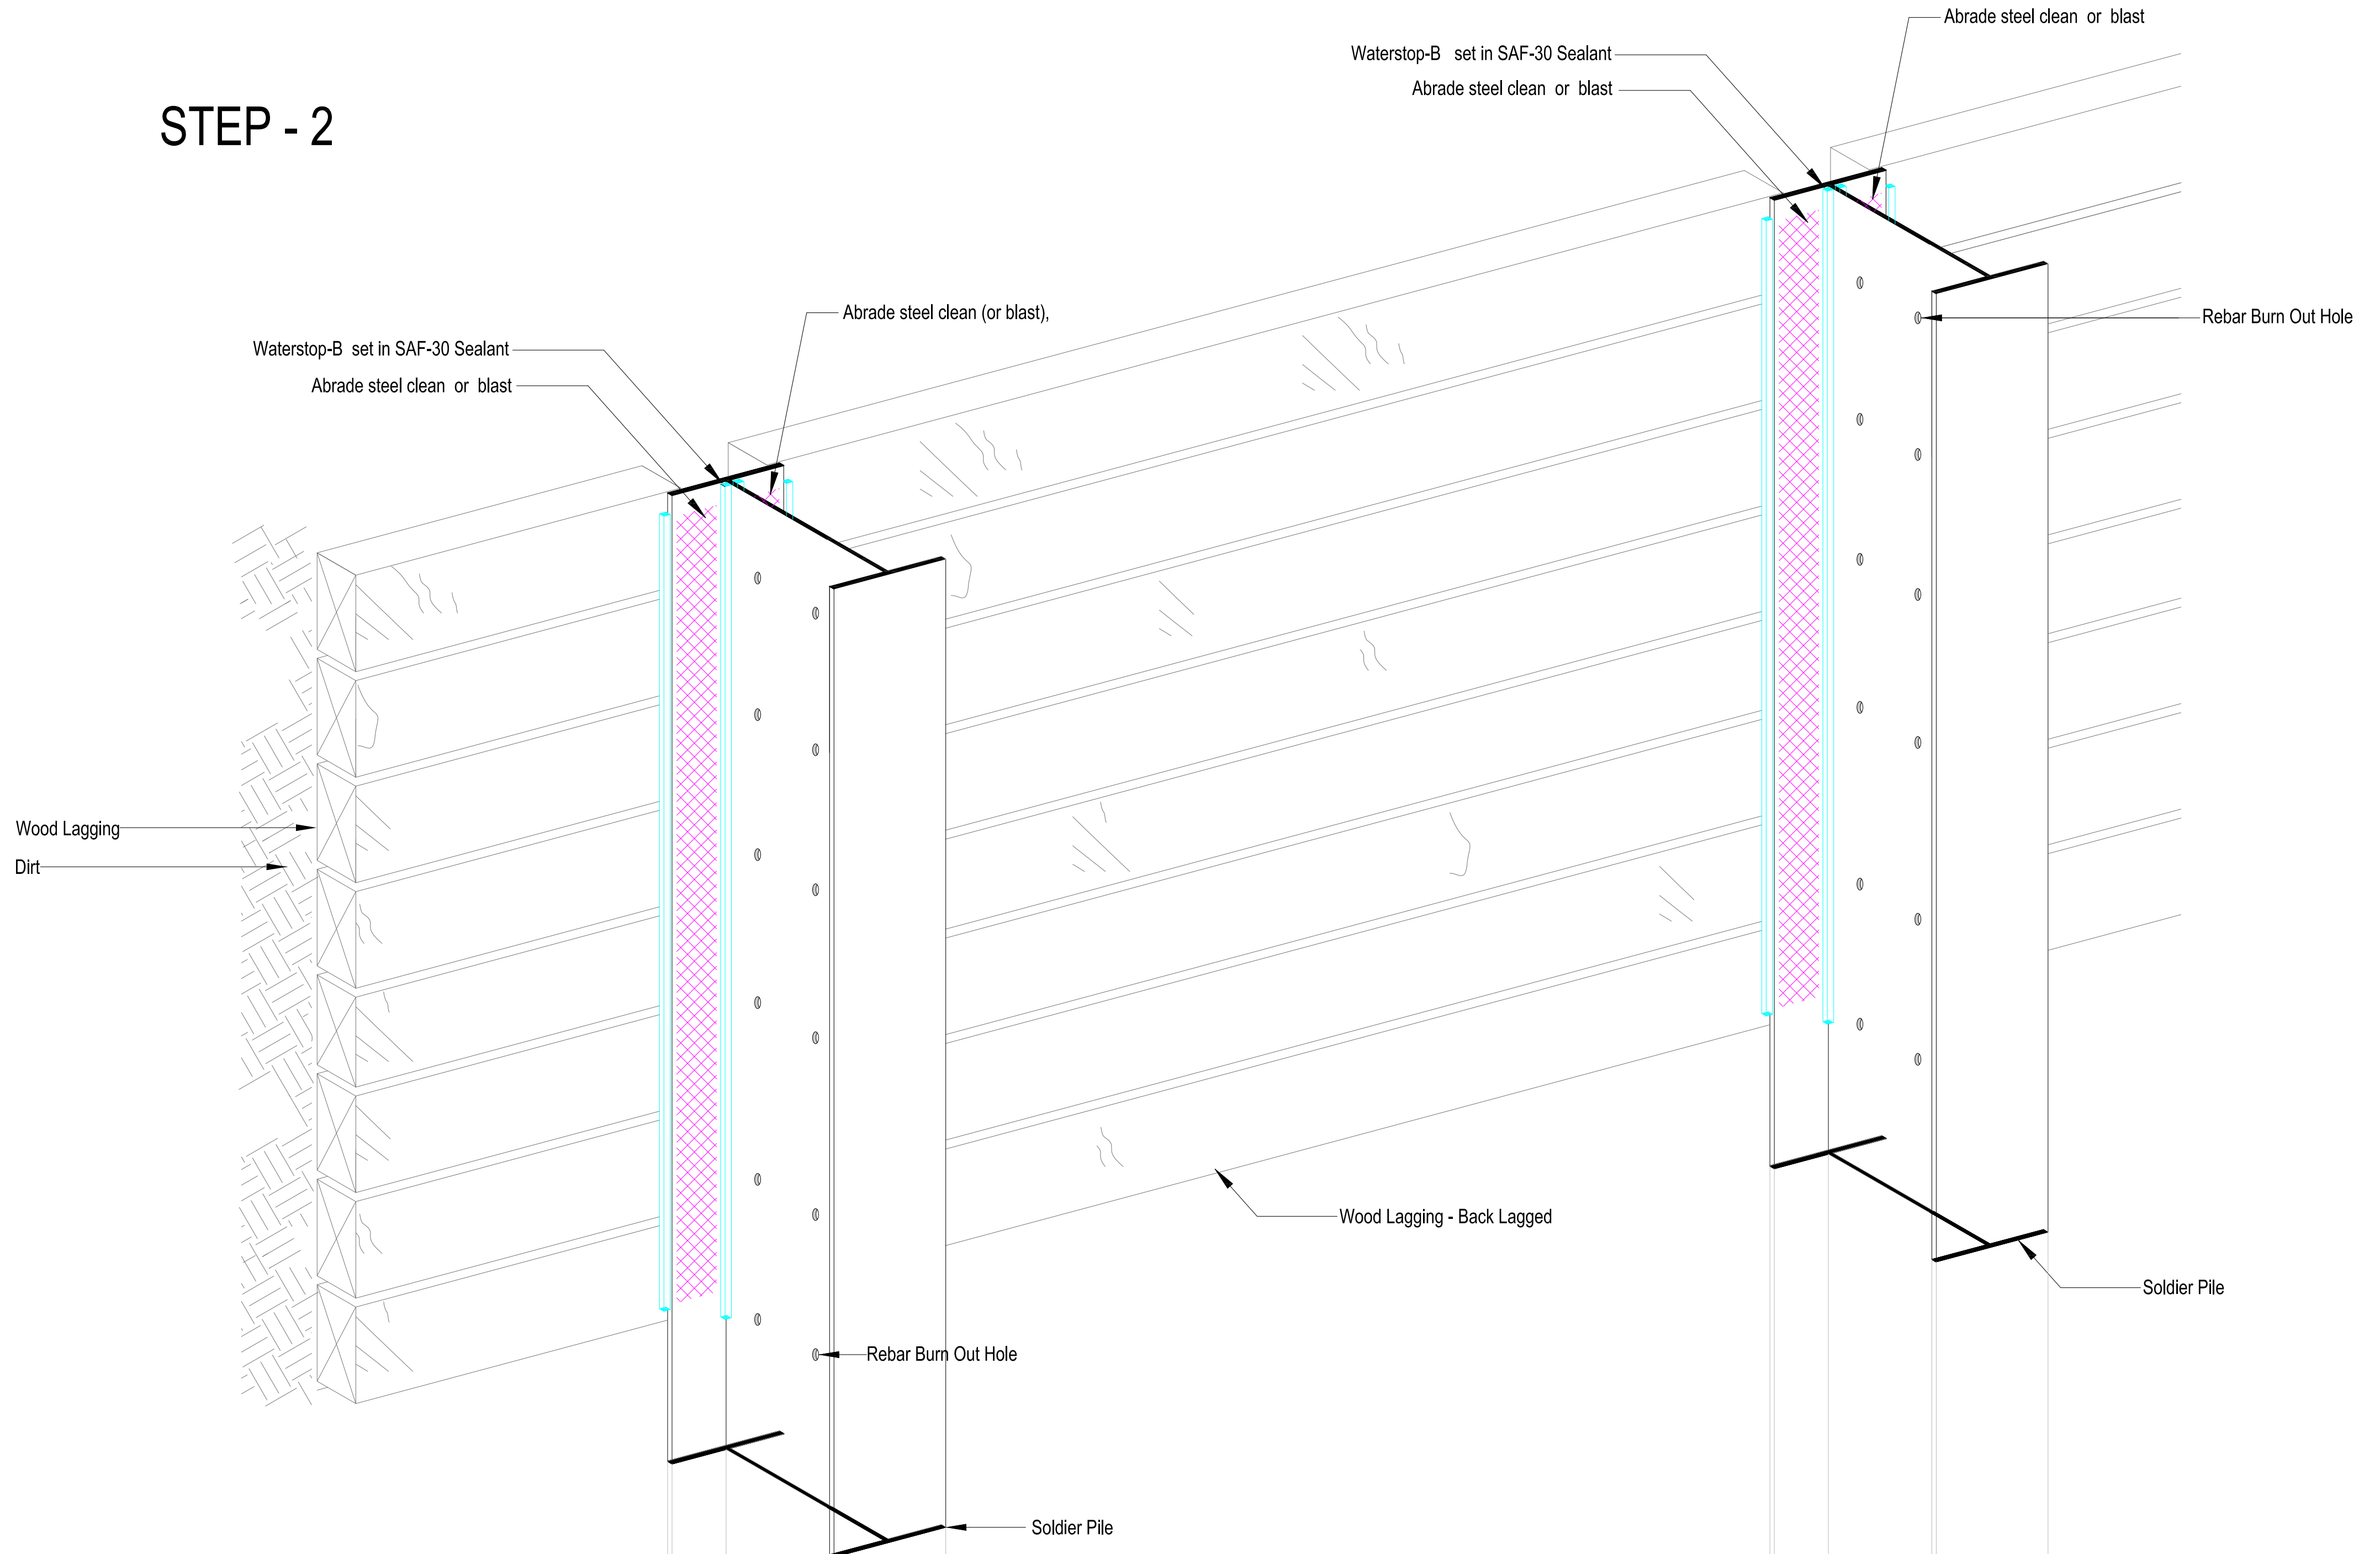
STEP - 2

SHORED WALL BACKLAGGED CONDITION

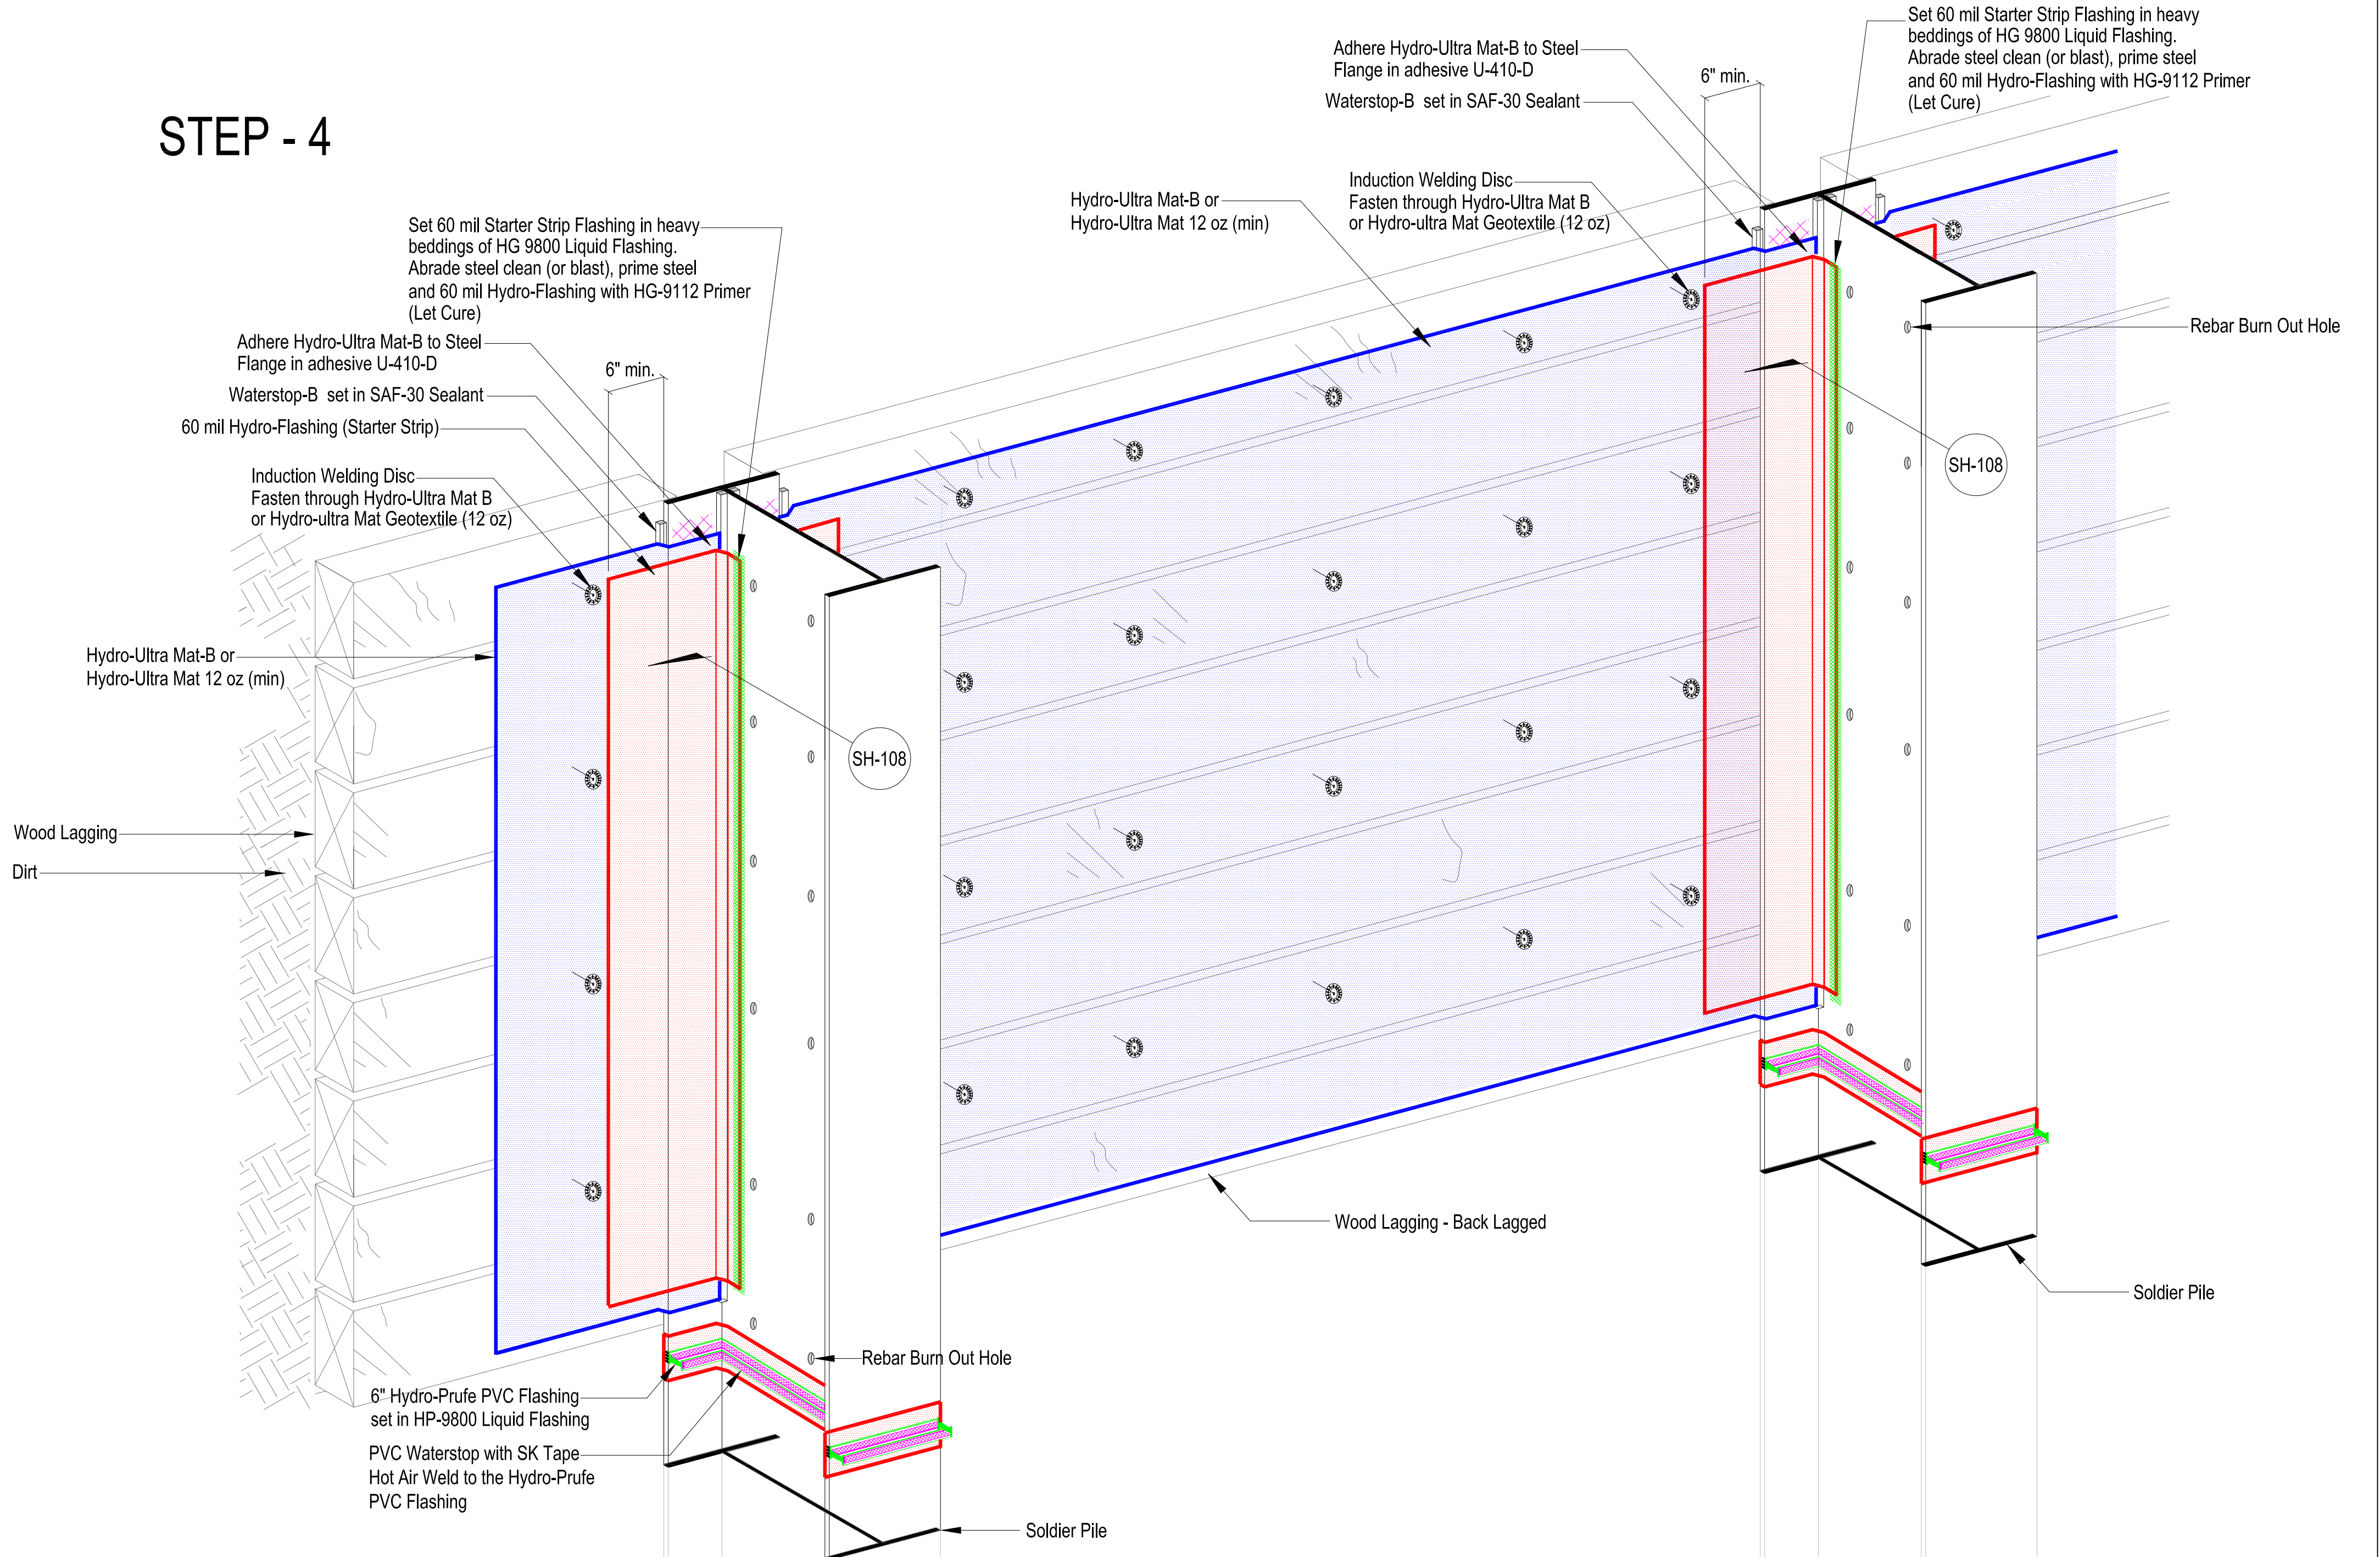
STEP - 4

**SHORED WALL
 BACKLAGGED CONDITION**

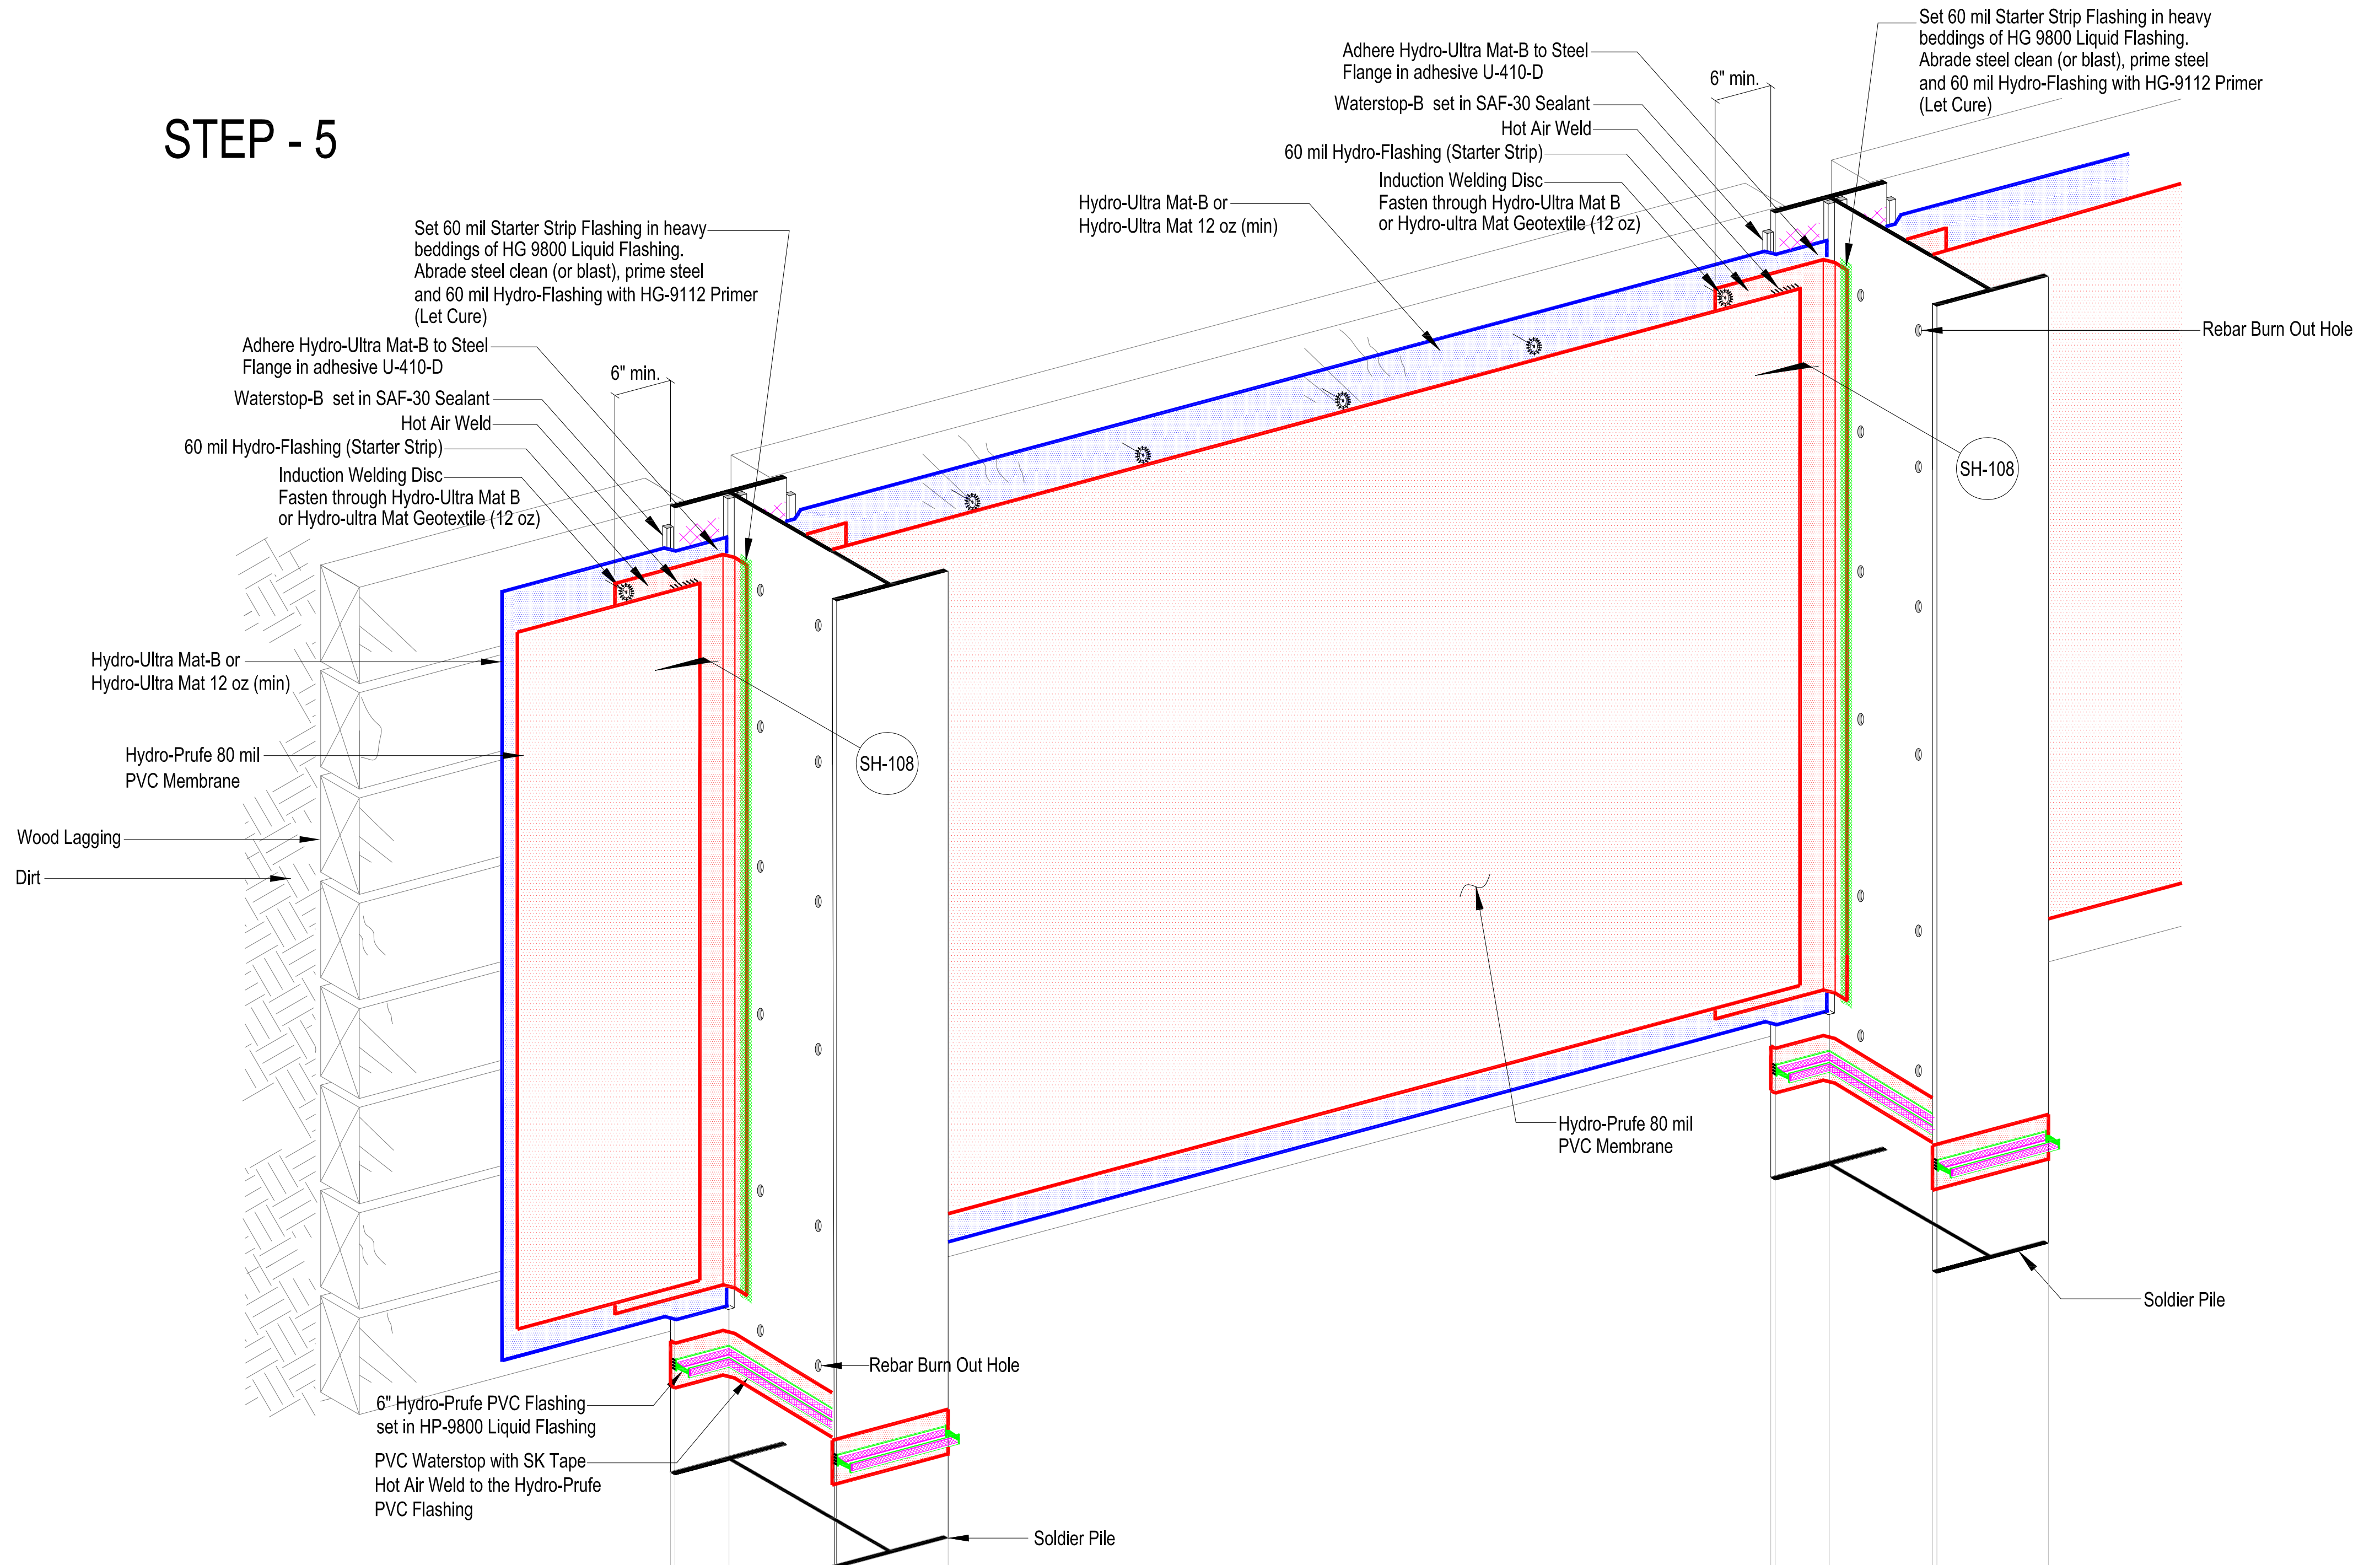
STEP - 5

DETAIL NAME:
**SHORED WALL
 BACKLAGGED CONDITION**

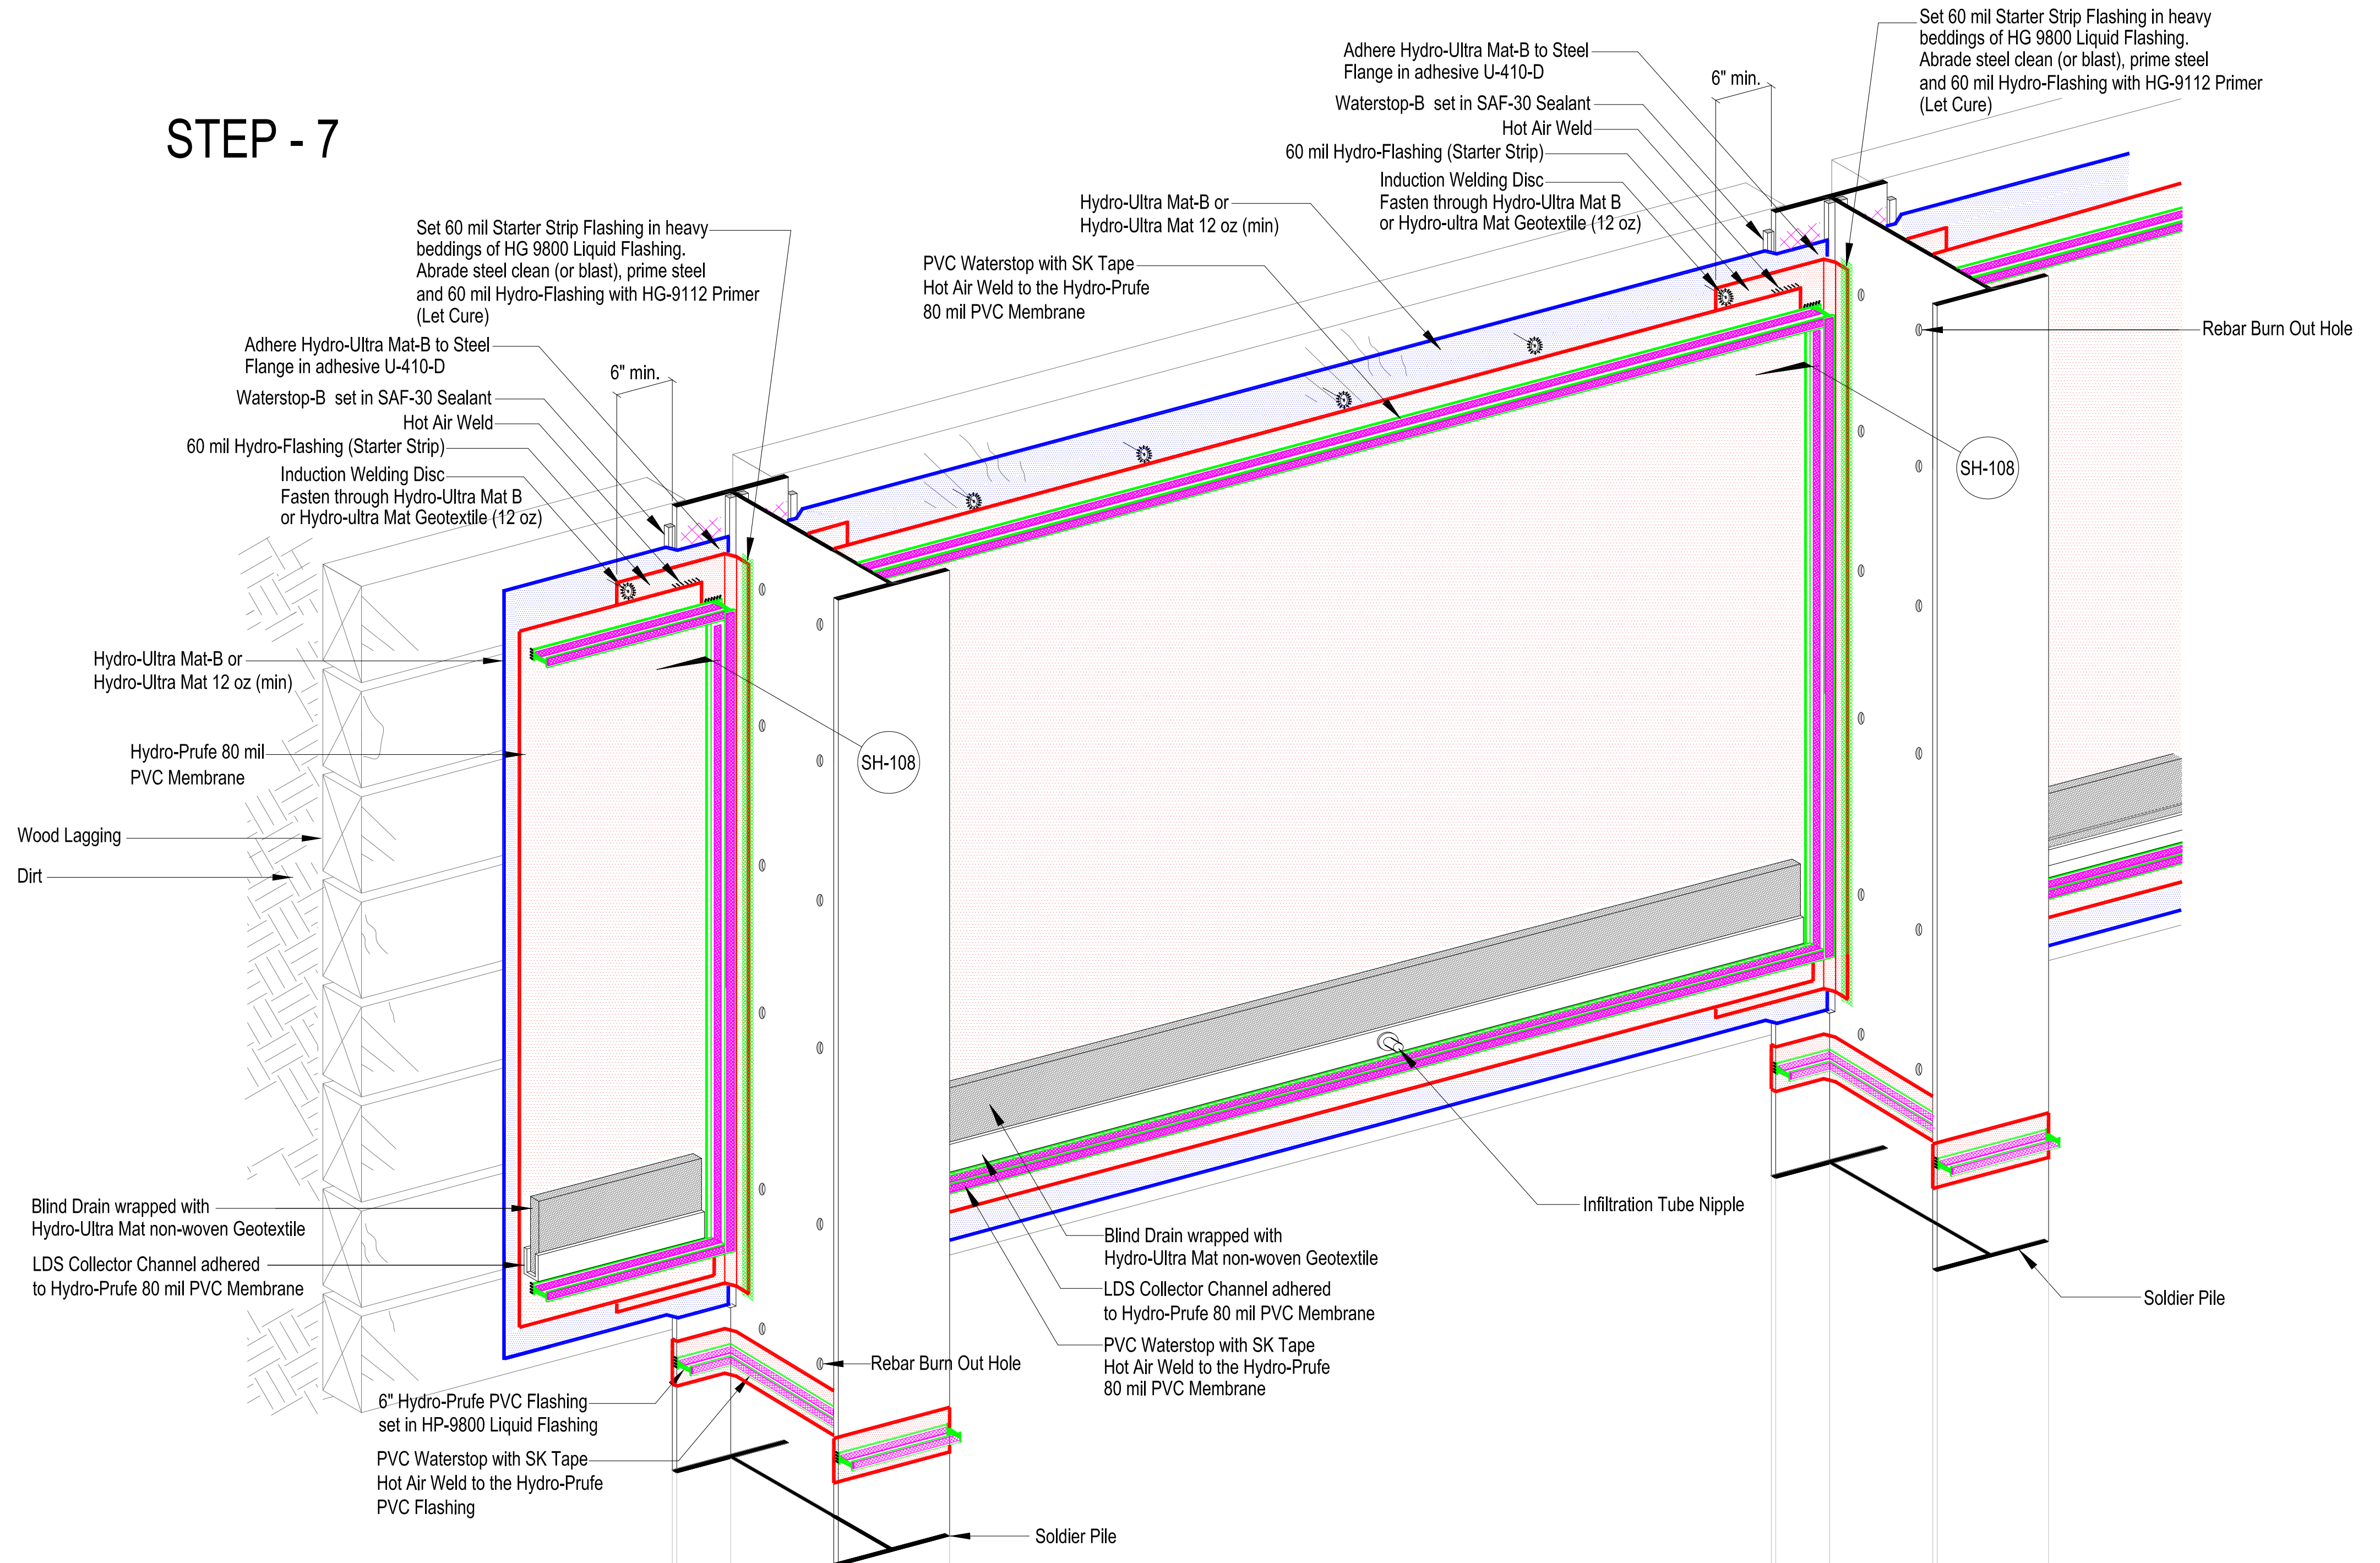
STEP - 7

**SHORED WALL
BACKLAGGED CONDITION**

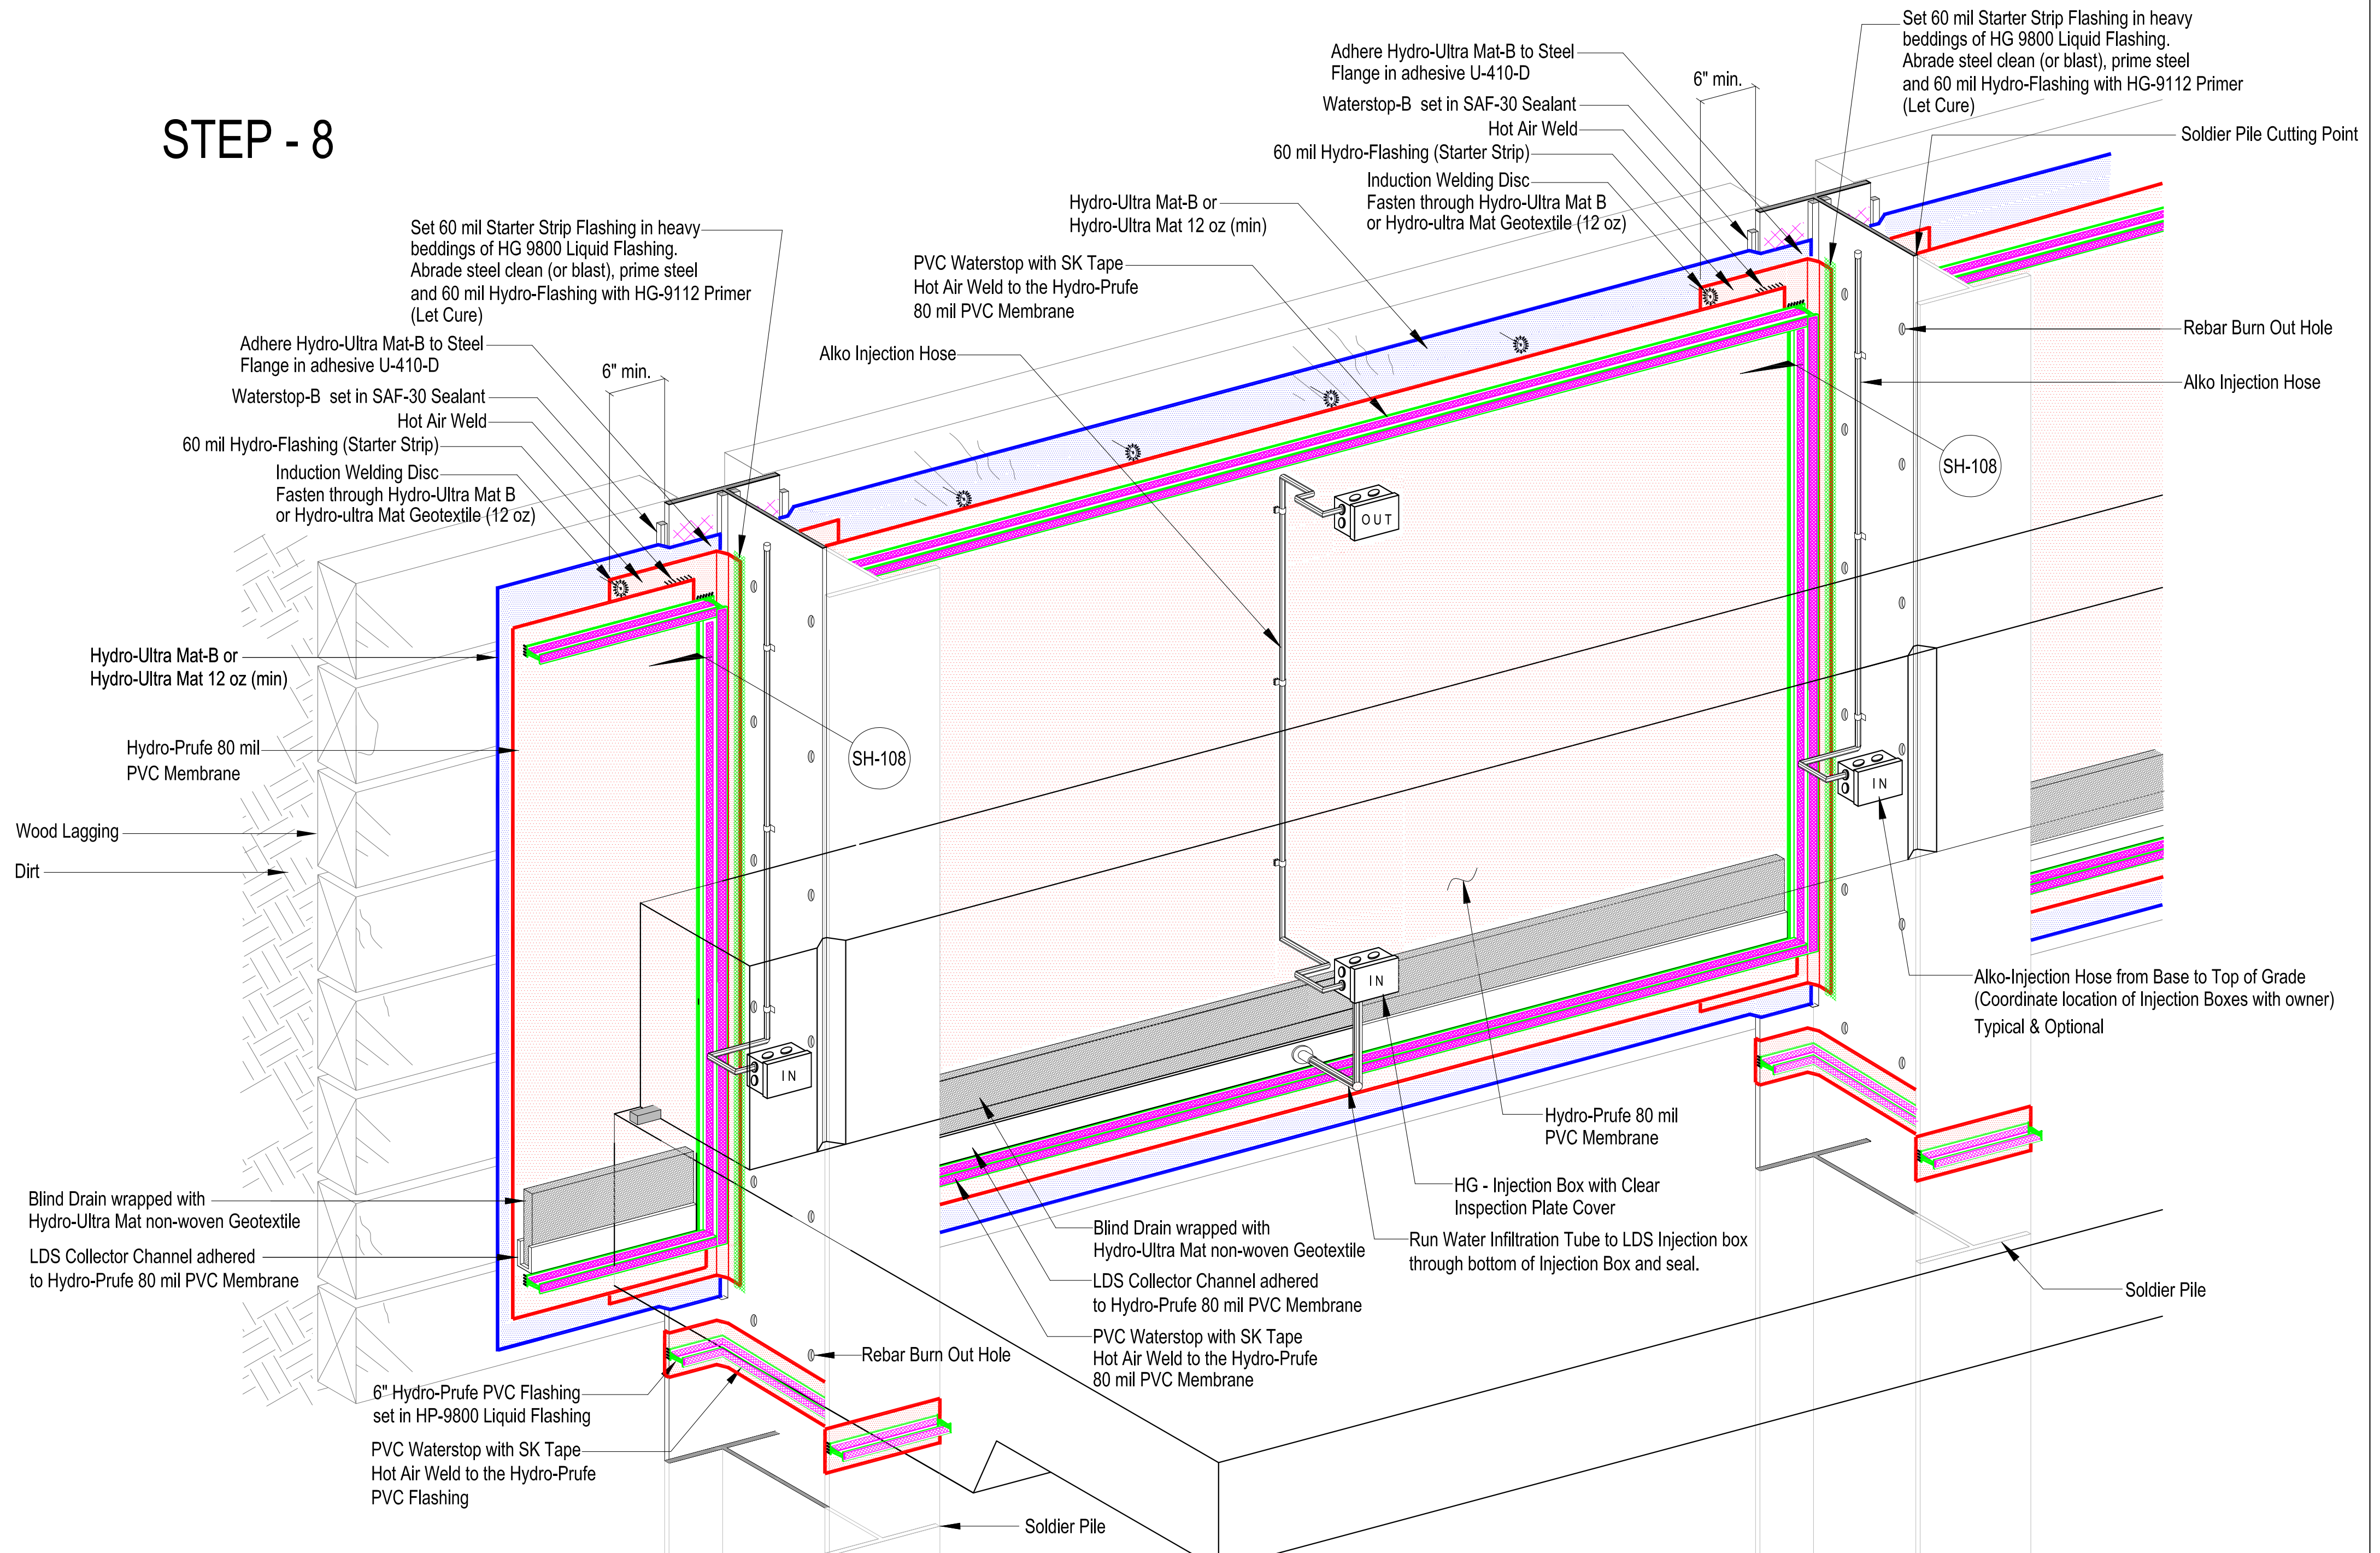
STEP - 8

SHORED WALL BACKLAGGED CONDITION
